August 11, 2016

Subject: Enhanced Evaporation Pilot Test, Progress Report #2

Sprinkler Irrigation Pilot Test Layout
VLT Heap Leach Pad
(all operations are on SPS private land)

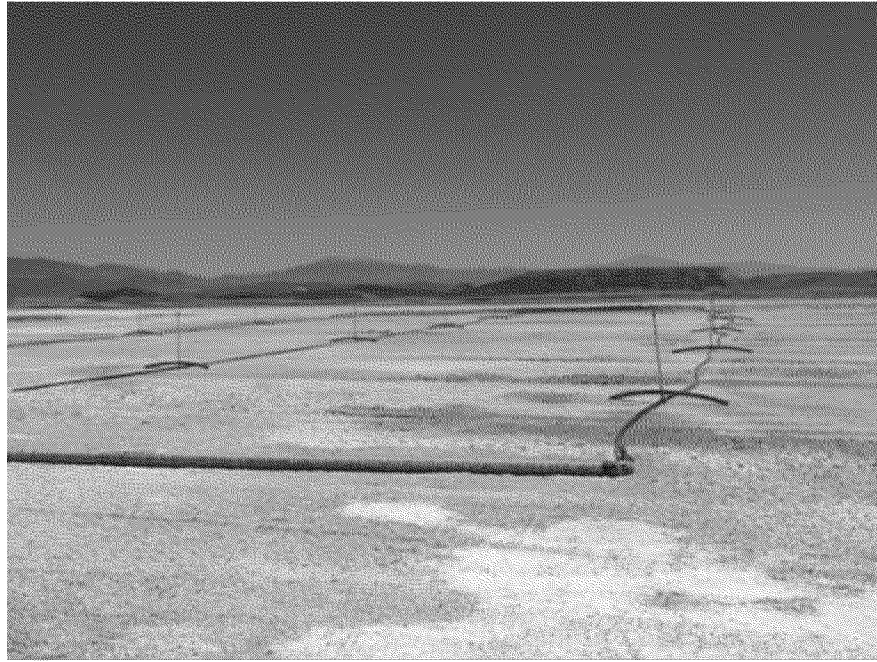
Evaporation panels before system operation on August 3, 2016 (10,000 gal/day)

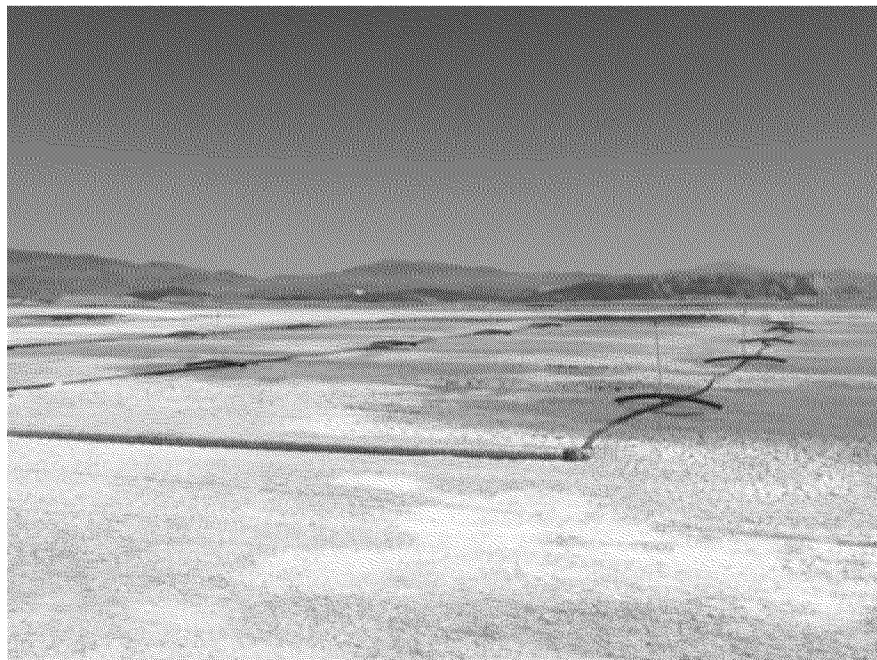
- Precipitate crust continues to form on surface of the VLT HLP in the area of the sprinkler panels (before & after pumping photos are attached). Fluid appears to pond on top of this crust during pumping operations. SPS does not see this as a negative issue as the crust provides a barrier for fluids to soak into the top of the HLP. This appears to minimize the potential for recirculation of fluids back to the liner system.

Evaporation panels after system operation on August 3, 2016 (10,000 gal/day)
